## Greenkeeping Presentation March 2022

By Head Greenkeeper: Ian Whiteley

## Course Maintenance

## **WINTER PROJECTS**

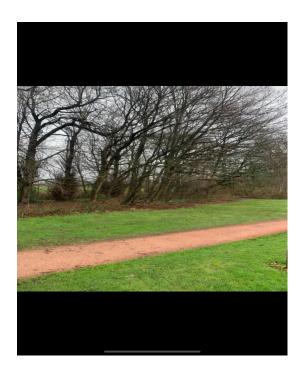
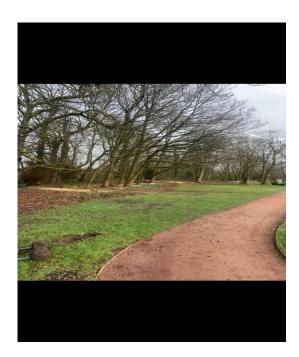
Once we had completed the work on the 7<sup>th</sup> Tee it highlighted how messy and overgrown the left of the 7<sup>th</sup> hole had become from Tee to Pond. We methodically worked through the trees removing lower limbs, saplings and self seeders. The logs from the trees we removed, were used to build ecology houses.

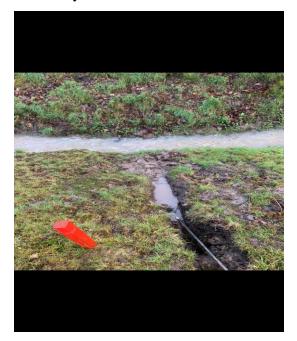
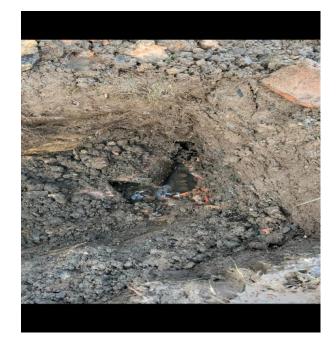
The outlet that we found going in to the  $6^{th}$  Brook we dug out and found two more blockages. This was causing a backup of water, up between the  $1^{st}$  Tee and  $6^{th}$  hole.

We reconnected the two blockages and that allowed us to get 100 rods from the outlet in the brook to the right hand green side bunker on the 6<sup>th</sup> Green, this is now running free.

Unfortunately, that is the main for the now old and perished drainage system on the  $6^{th}$  Fairway (green side). All the laterals that run in to that main are blocked/collapsed, which explains why the

6<sup>th</sup> fairway is so wet.

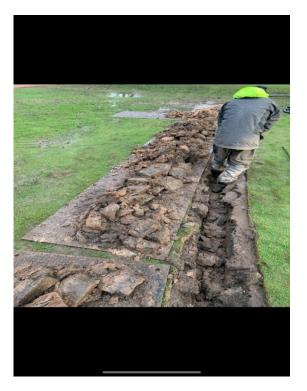
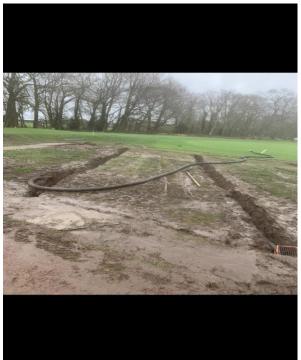
The left of the 6<sup>th</sup> showed itself to be one of the wettest areas on the course, certainly green side areas. We knew there was an outlet coming out in to the pond left of 7<sup>th</sup> yellow tee, but the system we found to try and help that area was minimal and again the stone used wasn't good enough for the water to peculate through to the pipes, so we hand dug roughly 60-70m of drainage lines, connected it to the outlet and backfilled with better materials, we also used new drainage pipe, the area was pure clay, we also found a couple of old clay drains falling in to that area which came from the left of the 6<sup>th</sup> green, we cleared them and let them flow in to our new system, this may help that green although these drains, which could be 50+ years old were too shallow, in my opinion. We got rid of the worst of the turf and used turf from the practice area on 9.. We've allowed it to settle and have sice fertilised the area to help the area recover.

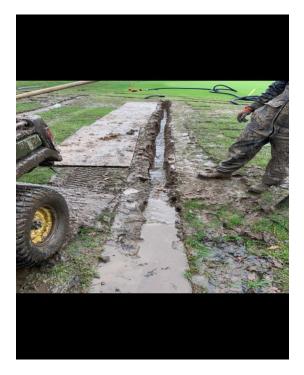
To stop the water from gathering, we installed a flood grid at the end of one of our drainage laterals, in the low spot near the Oak, to stop water building up there. The image on the left here shows how much water was being held here and the image on the right, shows a side profile of what the water was facing to get through to the pipes.

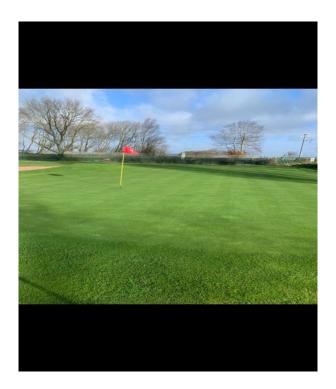
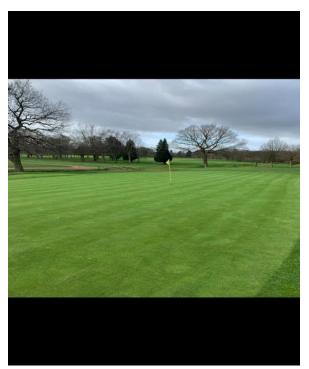
These photos where taken a few days after the final winter feed. Andy and Dan are now fully up to speed with hand mowing, which is a positive as we head in to the season.

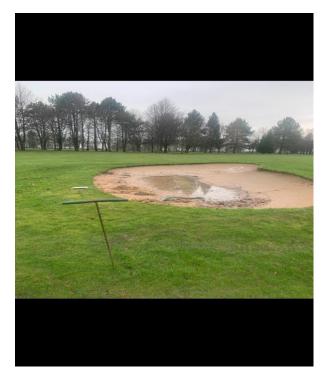
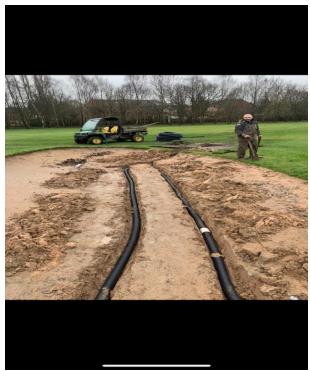
The bunker on the right of the 9<sup>th</sup> Fairway has had a new drainage system installed, which we connected to drains which were approx. 5m away from the bunker itself.

The bunker on the right of 18, has had a succession of boreholes dug in, to a depth of 2ft which we then backfilled with drainage stone and topped up with sand. The night after we completed these two jobs, we had 11mm of rain and both were dry the next morning and easy to rake. In the past this would have held water and GUR.

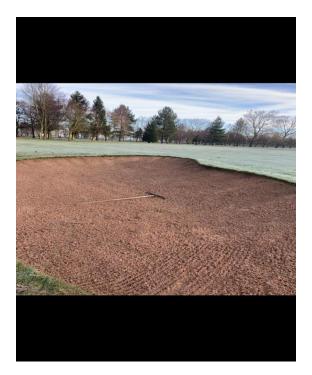
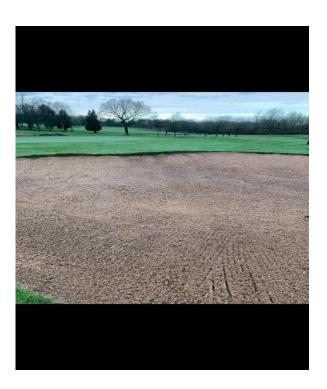
These were the two bunkers the next morning.

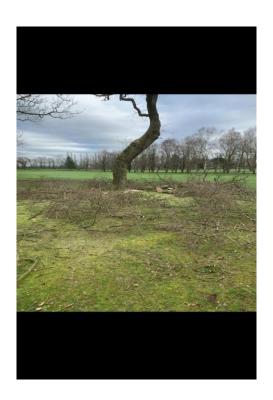
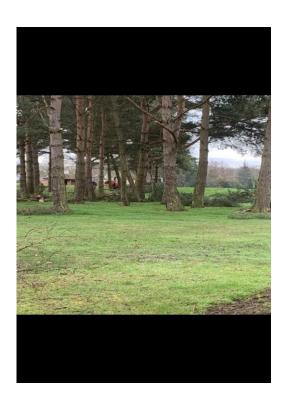
Our Tree Surgeons visited for a second time they concentrated on the Ash on 17, the overhanging limbs on  $16^{th}$  Green and the hung up Ash limb in between 12 and 13.

They also identified a dead tree on the treeline, right of 17, which was identified as dangerous, being right next to the road, this was felled. Three of the team chipped and tided behind them. To increase productivity, whilst they were working, we visited every tree down the left of 17, removing the lower limbs and giving a general tidy up, including the Oak which overhangs the modified bunker on the 11<sup>th</sup> Fairway.

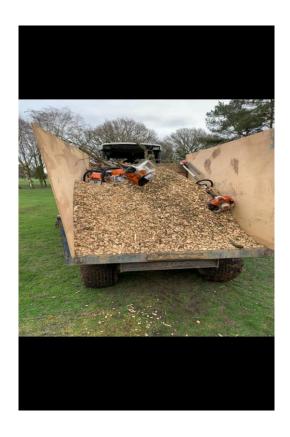
This picture shows the modified trailer to increase its capacity and really shows the chippers worth as the equivalent would have been 5 or 6 trailer loads of branches.

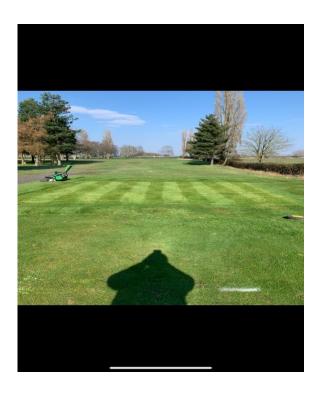
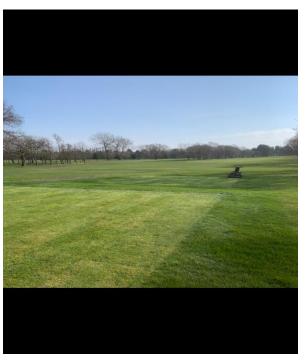
The new Tee on 17 and ladies 15<sup>th</sup> where given their first cut and shaping.

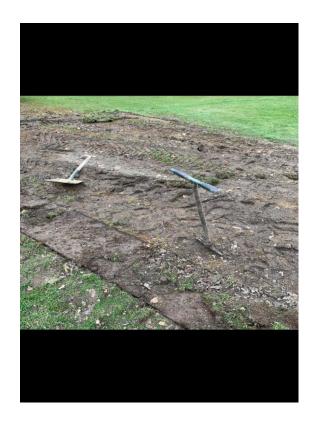
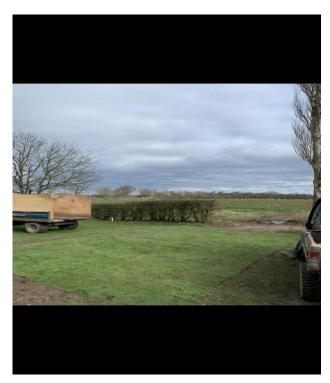
The worn area right of 15, which we have been using as an access point to our

dumping ground, needed tidying up, so we raked out two tonne of rootzone and used turf of the 9<sup>th</sup> practice area to speed up its recovery.

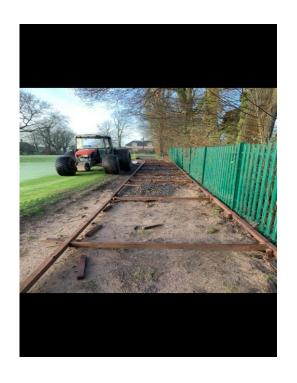
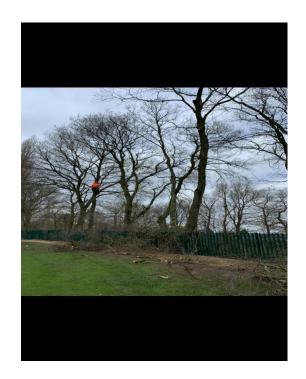
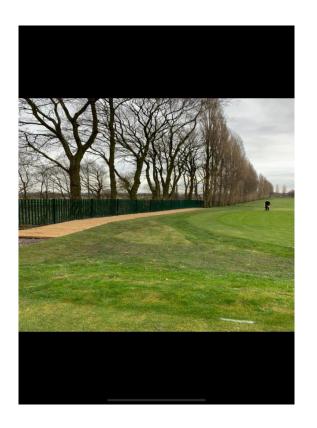
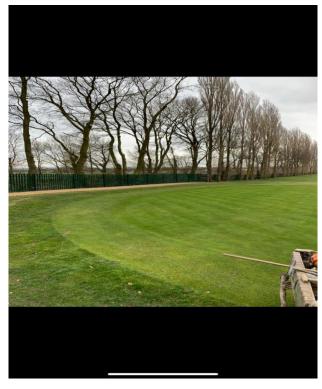
The project on the right of 16<sup>th</sup> Green is almost complete. The frame has been built, the Oak trees overhanging have been crown raised and branches chipped. The frame has been back filled and roughly levelled with grit sand. The surrounds have been returfed and landscaped. The path at the back of the 11<sup>th</sup> Tee has been raised to meet the edge of the frame, this just needs a final levelling. To complete the project, we will lay the astroturf.
